### Plattsmouth, U.S.A.

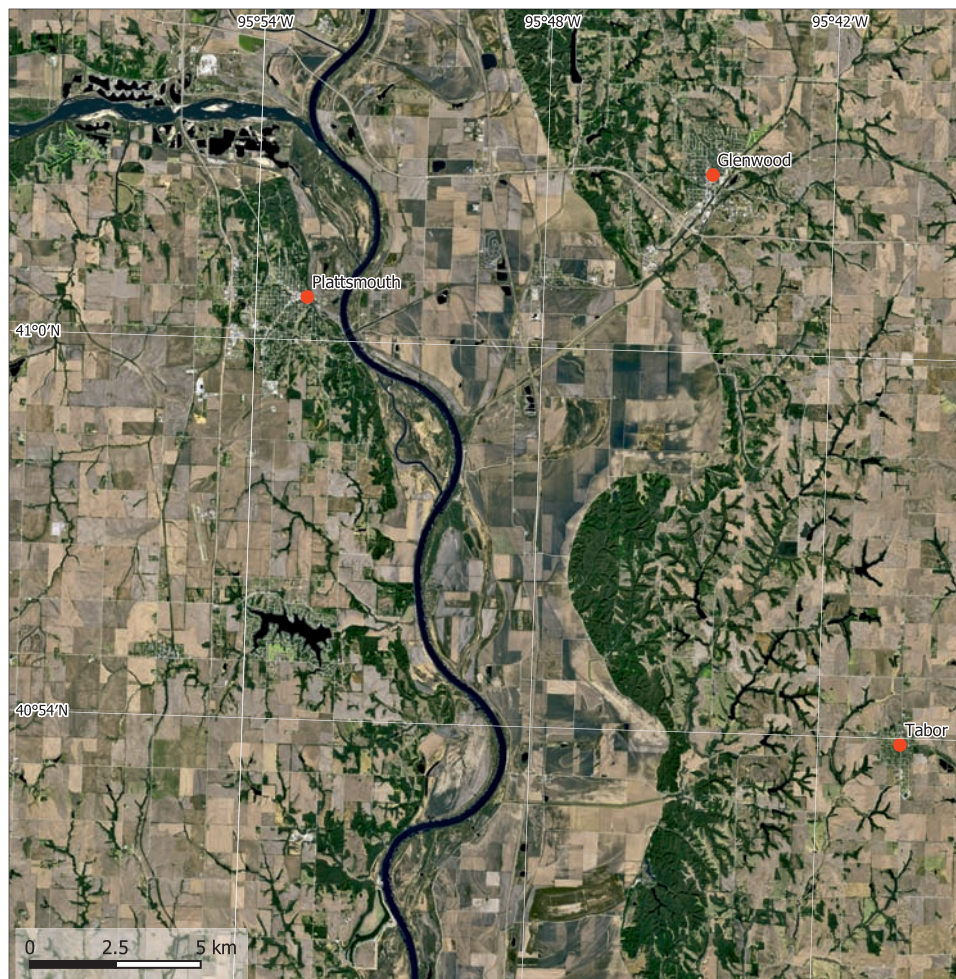
1. Plattsmouth, U.S.A., 2023-03-21. Data: Sentinel-2.

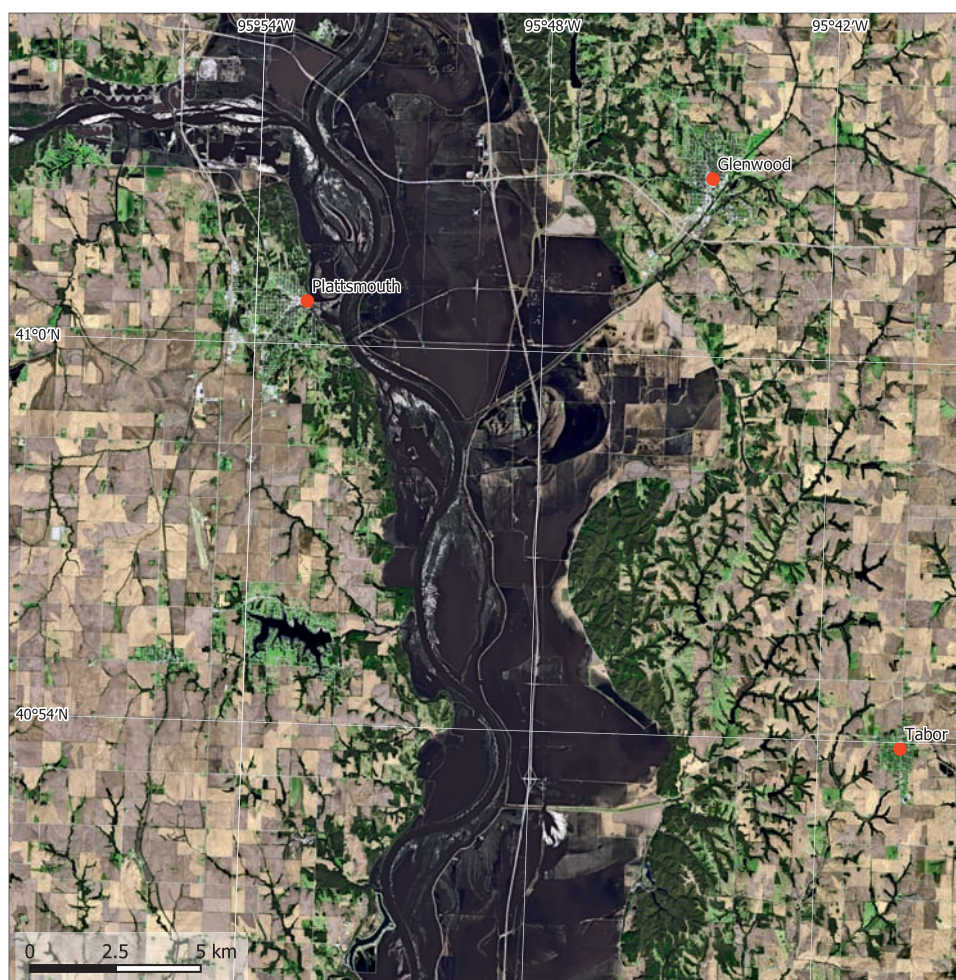
2. Plattsmouth, U.S.A., 2019-03-31. The valley around the Platte and the Missouri rivers is flooded, only a few infrastructure elements such as highways and dams remain dry. Data: Sentinel-2.

Satellite images captured the dramatic expansion of the floodwaters, which swallowed entire communities and vast swaths of farmland. Moreover, the data allow for accurately estimating the affected areas and the damage caused by the flood.

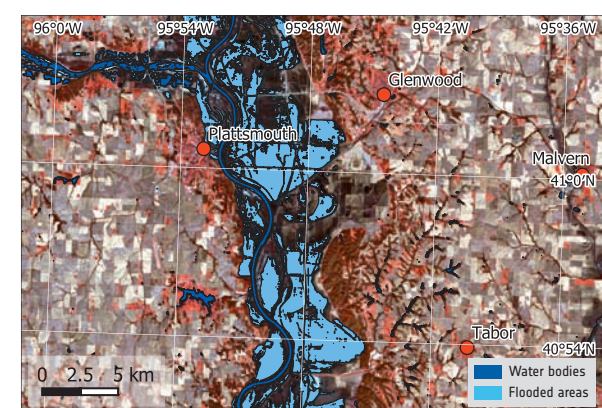
3. False-colour infrared image of Plattsmouth, 2019-03-31. Overlay: water surfaces derived from satellite data. Data: Sentinel-2.
