A flood disaster occurred when the **Kakhovka Dam**, a large hydroelectric dam on the Dnipro River in southern Ukraine, was destroyed in the context of the ongoing war in Ukraine. This event caused severe flooding, affecting settlements, farms, and ecosystems over a wide area.

## Exercises

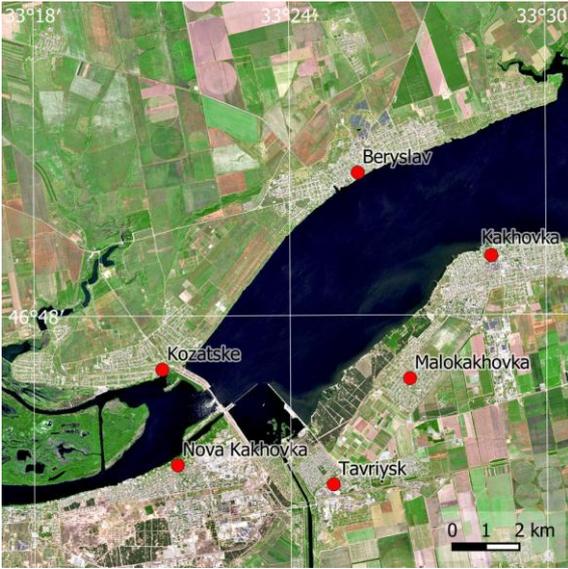
Kakhovka dam before the breach (2023-06-05, Sentinel-2).

- Look at the detail satellite image from 2023-09-13 and compare it with the image acquired on 2023-06-05, before the dam was destroyed. Which changes can you detect?

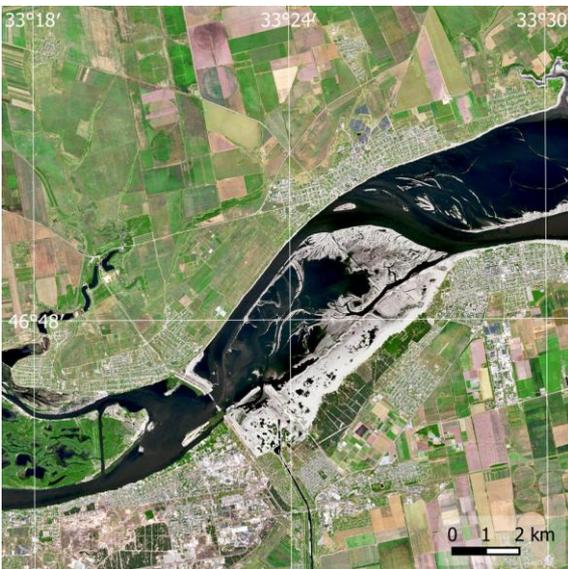
The storage lake empties (2023-06-20, Sentinel-2).

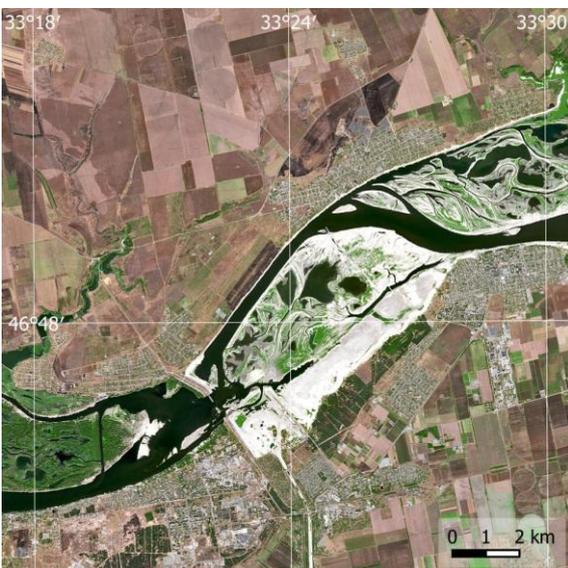
Three months later (2023-09-13, Sentinel-2).

- Focus on the area of the original bed of the storage lake. What structures have become visible?
- Look at the areas surrounding the storage lake. What does the change in colour tell you about seasonal changes or about land use? Think about harvesting activities.

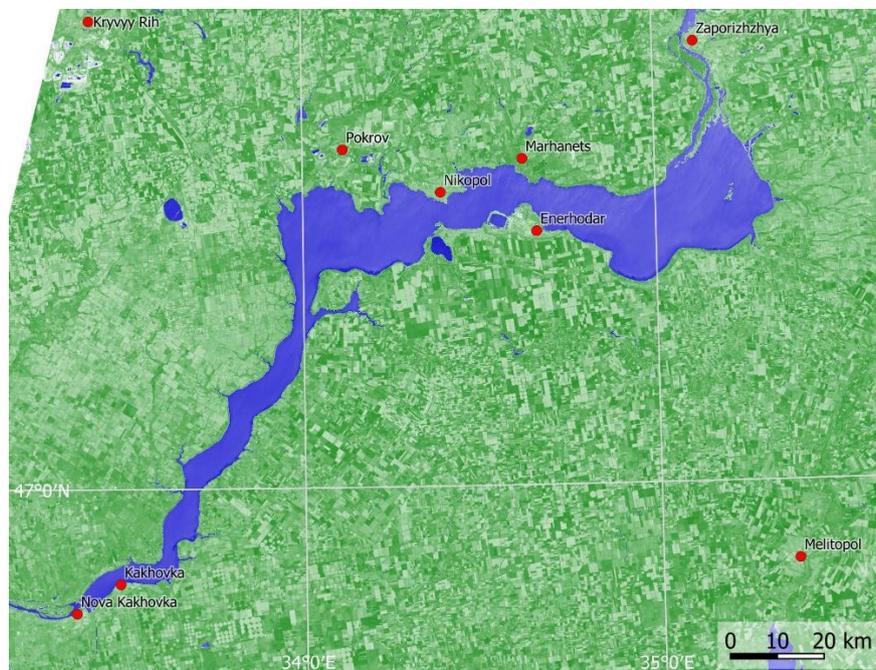
Overview of the extent of the Kakhovka reservoir before the destruction of the dam (2023-05-06, Sentinel-2).  
(NDWI, normalized difference water index; blue: water surfaces, green: other land cover)

- Look at the overview image below and try to estimate the area originally covered by the storage lake (average width of the lake, approximate length). Use the scale bar in your considerations.
